# BEYOND MISINFORMATION

What Science Says About the Destruction of  
World Trade Center Buildings 1, 2, and 7

ARCHITECTS  
& ENGINEERS  
*for 9/11 TRUTH*

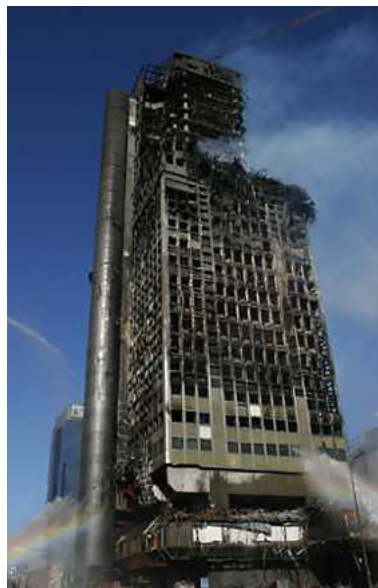
*The Windsor Tower after having burned for almost 24 hours.*

stages over several hours, of floors where the steel support columns and beams had no fire protection. In 2008, the 13-story Delft University Faculty of Architecture Building in the Netherlands, constructed of reinforced concrete, burned for seven hours and experienced a partial collapse of a 13-story section of the building. Yet there remains no documented instance of a steel-framed high-rise building suffering total collapse from fire, and only a small number have experienced partial collapse.

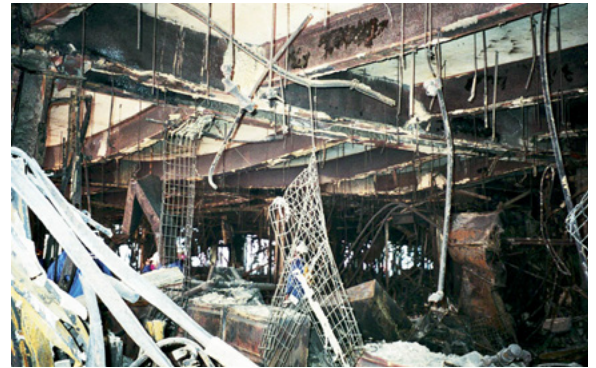
Fire damage in WTC 5 (2002 NIST survey of fires that resulted in total or partial collapse).

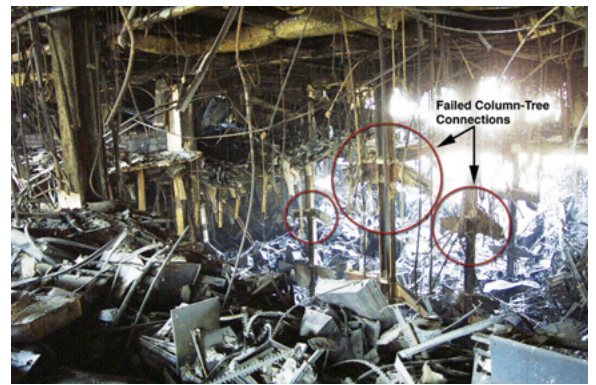
Partial connection and floor failures in WTC 5 (2002 NIST survey of fires that resulted in total or partial collapse).

- **One New York Plaza** experienced local connection failures resulting in filler beams dropping onto their supporting girders on two floors.
- **Alexis Nihon Plaza** experienced a partial collapse of its 11<sup>th</sup> floor, which was arrested by the floor below it.
- **WTC 5** experienced partial collapses of four floors and two bays.

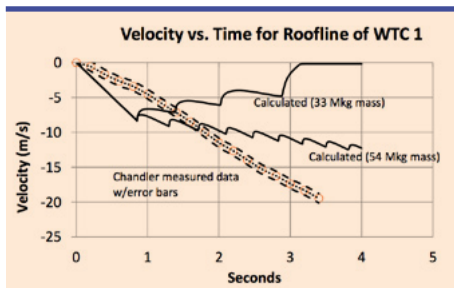
In this graph from Szamboti and Johns' Discussion paper, the observed velocity of the roofline of WTC 1 is compared with the velocity calculated using Bazant and Le's analytical method, but with corrected input values, showing significant decelerations at each floor.<sup>11</sup>

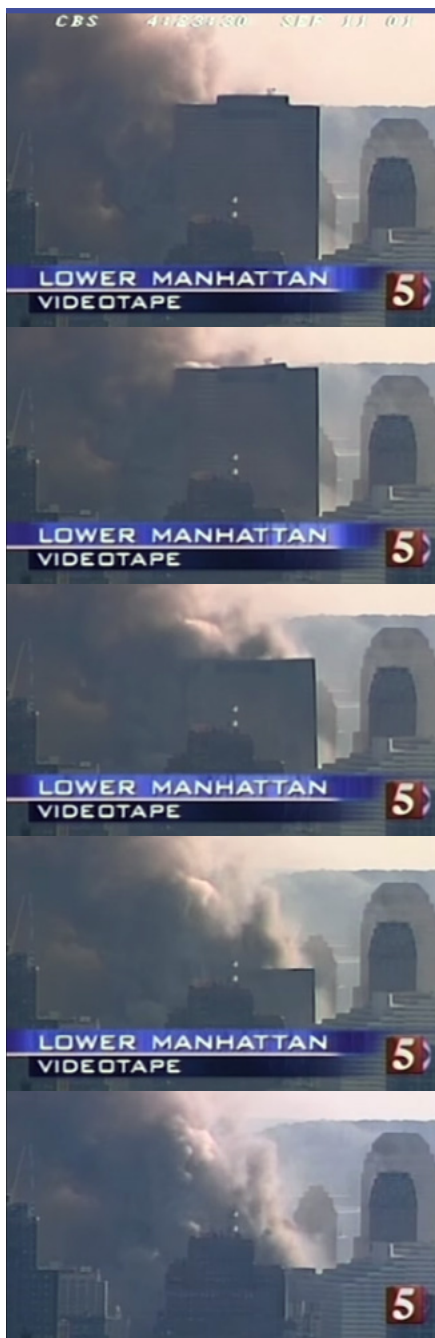
WTC 7 is shown falling symmetrically into its own footprint. It accelerated at free fall for 2.25 seconds of its descent.

Today, NIST acknowledges that WTC 7 fell at a rate of free fall (or the rate of gravity) for a period of approximately 2.25 seconds before it started to

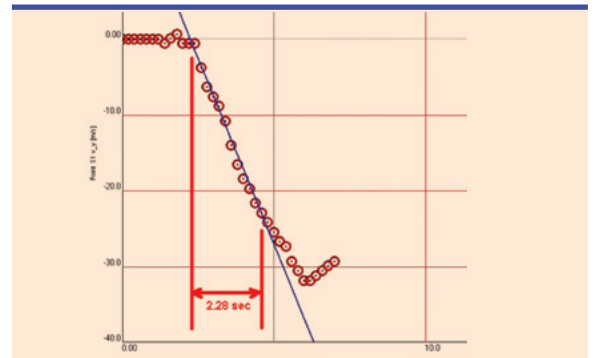
David Chandler's graph from Part 3 of "NIST Finally Admits Free Fall" plots the velocity of WTC 7's roofline versus time. The slope shows a free-fall rate of acceleration. The sudden change in slope shows the sudden onset of free fall.

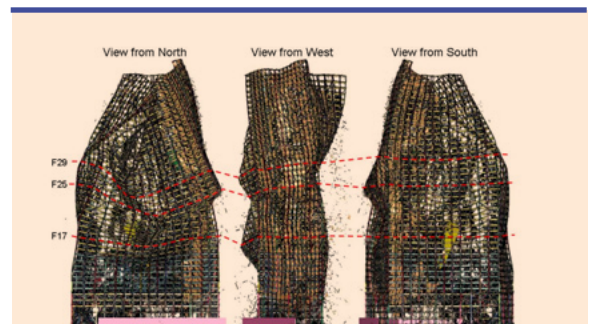
NIST's model of WTC 7's collapse shows large deformations to the exterior of WTC 7 not observed in the videos, while failing to show 2.25 seconds of free fall.

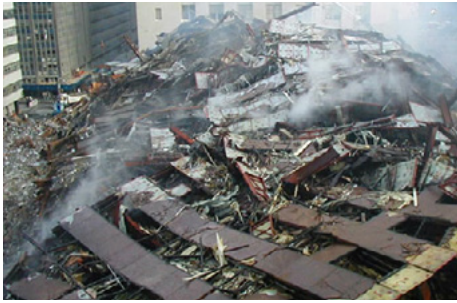
WTC 7's steel structure was dismembered and deposited into a compact debris pile.

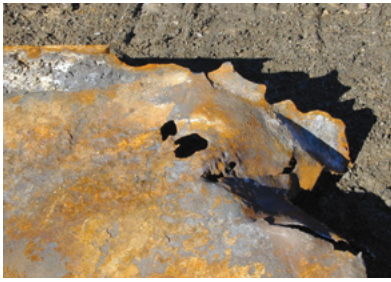
The eroded, sulfidated steel from WTC 7 at the scrapyards before it was cut off and taken for testing.
